ADVANCED GAS TURBINE (AGT) POWERTRAIN SYSTEM DEVELOPMENT FOR AUTOMOTIVE APPLICATIONS

**FIFTH SEMIANNUAL PROGRESS REPORT
(JANUARY 1982 — JUNE 1982)**

Engineering Staff of
Garrett Turbine Engine Company
A Division of The Garrett Corporation

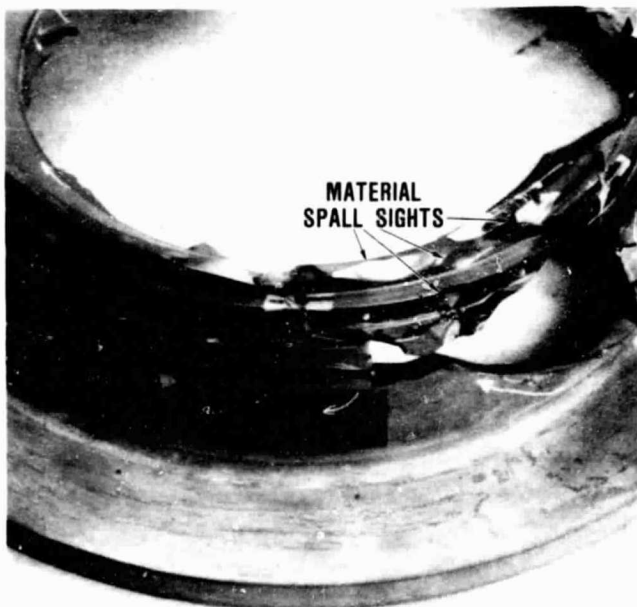
Figure 37. Spalling Near the Seal Land Region on ACC Turbine Shroud, S/N 174.

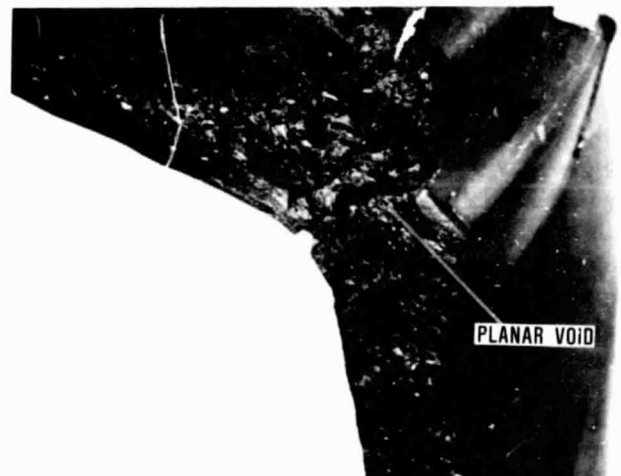
Figure 41. Processing Void in Carborundum Turbine Shroud, S/N 16-3.

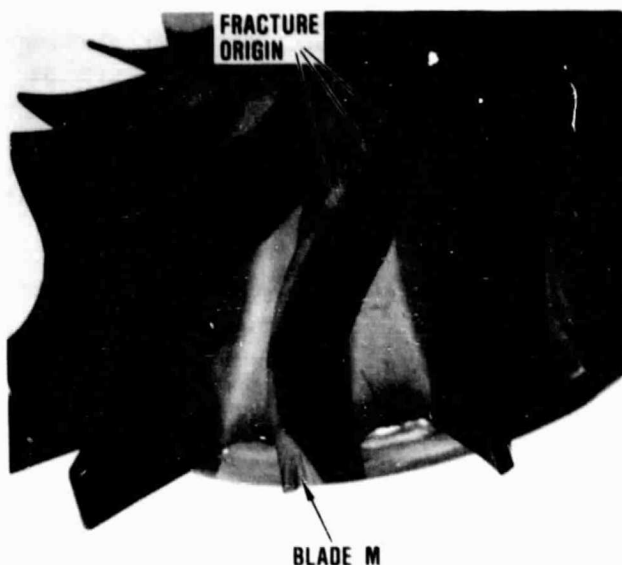
Figure 45. Blade Fracture Origin, Blade M, ACC Rotor, S/N 10191, After 83,000 RPM.

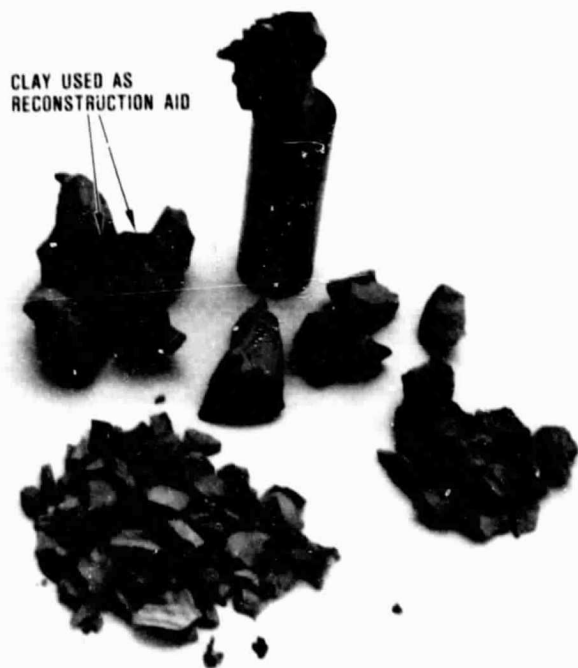
Figure 46. Remains of ACC Rotor, S/N 10191, Partially Reconstructed After Failure at 93,400 RPM.

The second spin test achieved 95,300 rpm at which time complete rotor destruction occurred. Partial reconstruction of the rotor, illustrated in Figure 46, was possible since

In conclusion, the 95,300 rpm rotor burst results are encouraging from two standpoints. First, the fact that rotor fractures initiated from surface sites, and the lack of observable interior defects confirm the rotor hub integrity. Rotor hub integrity initially was substantiated with the successful spin testing of the bladeless simulated ACC rotor to 115,000 rpm. The current bladed rotor testing indicates the successful transfer of this technology to the

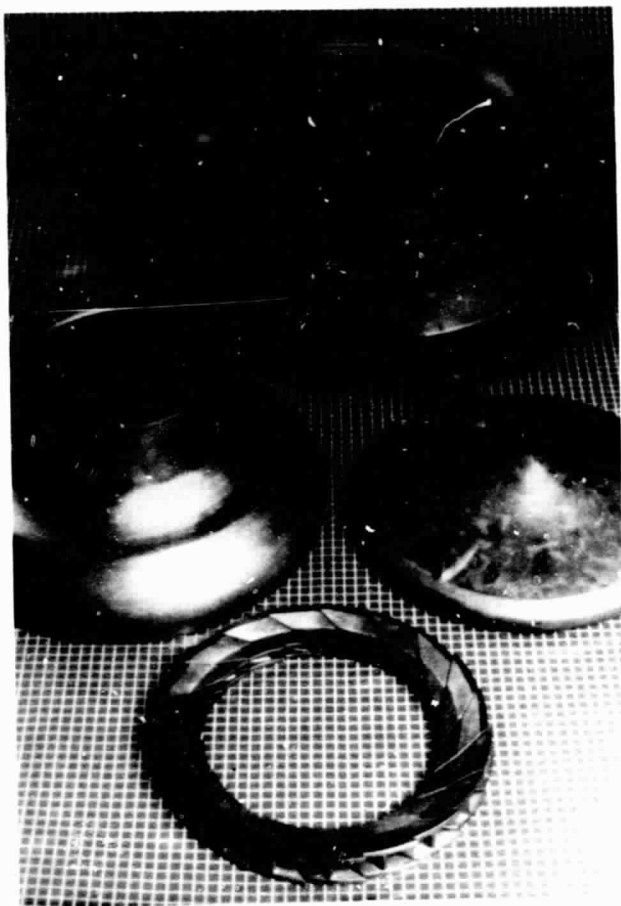
Figure 72. Turbine Shroud, Transition Duct, Combustor Baffle, and Stator Segments.

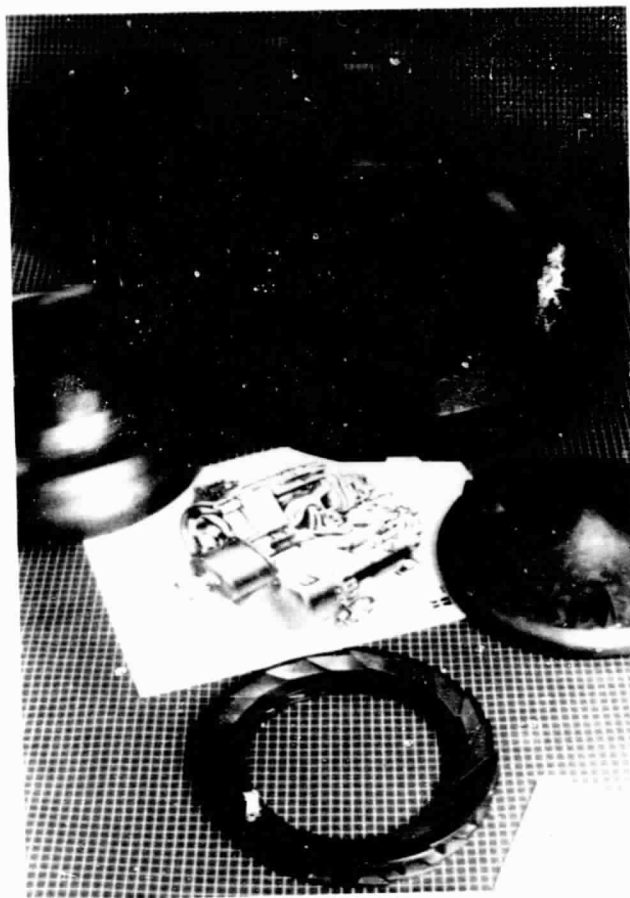
Figure 73. Turbine Shroud, Transition Duct, Combustor Baffle, Stator Segments, and Combustor Liner (Liner is Fabricated from Hexoloy™ SA).
